**GOVERNMENT OF INDIA
MINISTRY OF CIVIL AVIATION
AIRCRAFT ACCIDENT INVESTIGATION BUREAU**

**FINAL INVESTIGATION REPORT OF
SERIOUS INCIDENT TO M/S JET AIRWAYS
LTD. ATR 72 AIRCRAFT VT-JCS
AT HYDERABAD ON 07/06/2014**

FINAL INVESTIGATION REPORT OF SERIOUS INCIDENT TO M/S JET AIRWAYS
ATR 72-212A AIRCRAFT VT-JCS AT HYDERABAD ON 07/06/2014

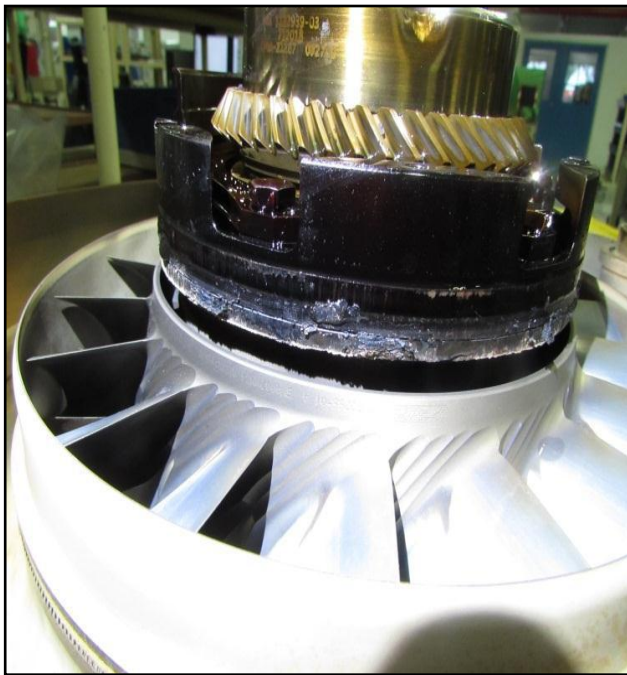
Preformed packing on LP diffuser case and ICC-GGC transfer tube packing was found flattened and hardened. Preformed packing on No. 4 bearing housing and NL sensor probe was also found deteriorated.

DETERIORATED PACKING OF NO. 4 BEARING HOUSING

As per the engine investigation report the oil stain on the ICC plenum is attributed to deteriorated preformed packing on No.4 bearing housing and flattened/ hardened preformed packing of NL sensor probe and inter compressor case transfer tubes. The engine sent for normal HSI or overhaul also exhibit similar findings of erosion, corrosion, fretting, Rubbing, oxidation etc. These findings are due to engine in-sevice condition and are only accessible when the Engine striped open at shop.

The reason of stickiness most probably is the service wear and tear. It has failed to provide adequate air supply (P3) during taxiing after landing at destination. This inadequate pressure across the bearing seal and the damaged packaging of #4 bearing housing in combination resulted in oil seepage into the air flow and contaminated P2.5 air was fed to the cabin.

- In view of the non-functioning of the Air Switching Valve which is an on condition item, the operator may carry out visual inspection of the Air Switching Valve during HSI and go for overhauling of the Air Switching Valves during the engine overhaul.
- To have better appreciation of the indications of deterioration of core engine during boroscope inspection, the line maintenance personnel may associate with the major overhaul and HSI.

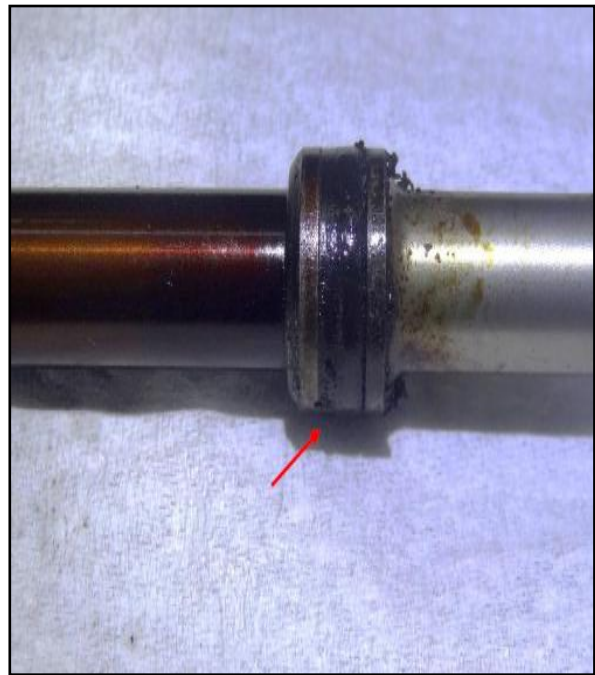
FLATTENED AND HARDENED PACKING OF NL SENSOR PROBE

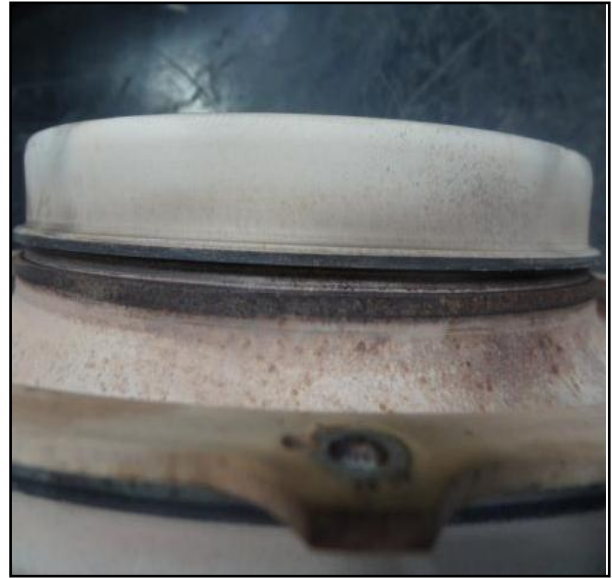
HPIMPELLER HOUSING

limits. Boroscope inspection revealed oil stain at HP impeller vanes, at 5'O clock & 6'O Clock position on Inter compressor case plenum, Gas generator case and inner front vane housing mating diameter. The engine was then strip examined and it was observed that almost the whole gas path (core engine) had oil stain marks, corrosion, fretting, rubbing etc. which were due to operational wear and tear. The engine investigation opined that these are unlikely to contribute to the oil smell in the cabin.

The reported oil smell in cabin and oil leak on HP impeller area was confirmed during disassembly and evidence of coked oil stain was observed on the HP impeller vane. Based on the hardware observations, the oil smell in cabin is attributed to the combination of P2.5/ P3 air switching valve (p/n: 3114892-01) being sticky, causing inadequate air supply across the bearing seal and deteriorated no.4 bearing housing (p/n: 3121731-01) that resulted oil seepage, which contaminated the P2.5 air system causing the reported oil smell into cabin.

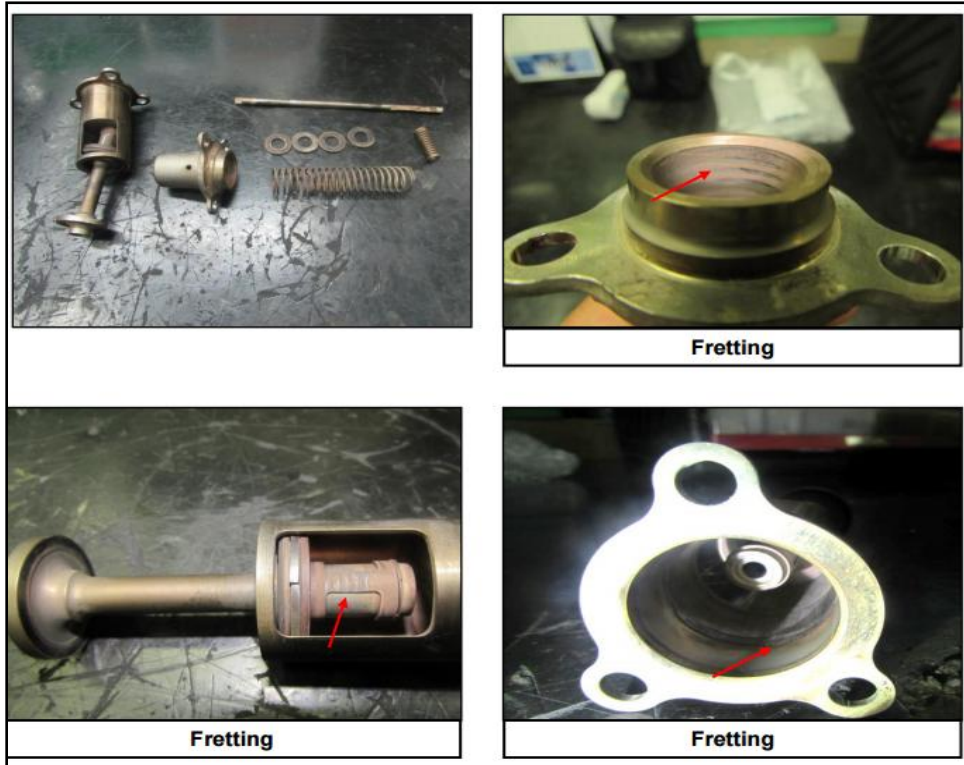
P 2.5/3 AIR SWITCHING VALVE

The four spacers were found installed in P2.5/P3 air switching valve, but the valve was found sticky during functional check. Fretting was observed on its cover, guide pin, inner housing and sleeve.

The hardware of the involved pressure switching valve (which ensures an adequate air supply for bearing cavity sealing) including the four spacers was found installed in P2.5/P3 air switching valve, but the valve was found sticky during functional check. Fretting was observed on its cover, guide pin, inner housing and sleeve.

Inadequate air supply across the bearing seal, required for prevention of oil seepage in the airflow, due P2.5/P3 air switching valve being sticky and deteriorated #4 bearing housing resulted in seepage of oil into P2.5 air system causing the oil smell & smoke in the cabin.
