**FINAL INVESTIGATION REPORT ON ACCIDENT TO  
GLIDER CENTRE PUNE L-23 SUPER BLANIK GLIDER  
VT-GLK AT GONDHALE NAGAR , PUNE ON  
09/03/2016**

On 09<sup>th</sup> March 2016, L23 Super Blanik glider, VT-GLK operated and owned by DGCA was involved in an accident during routine glider flying at Gondhale Nagar near Glider Center Pune, Hadapsar around 0900UTC.

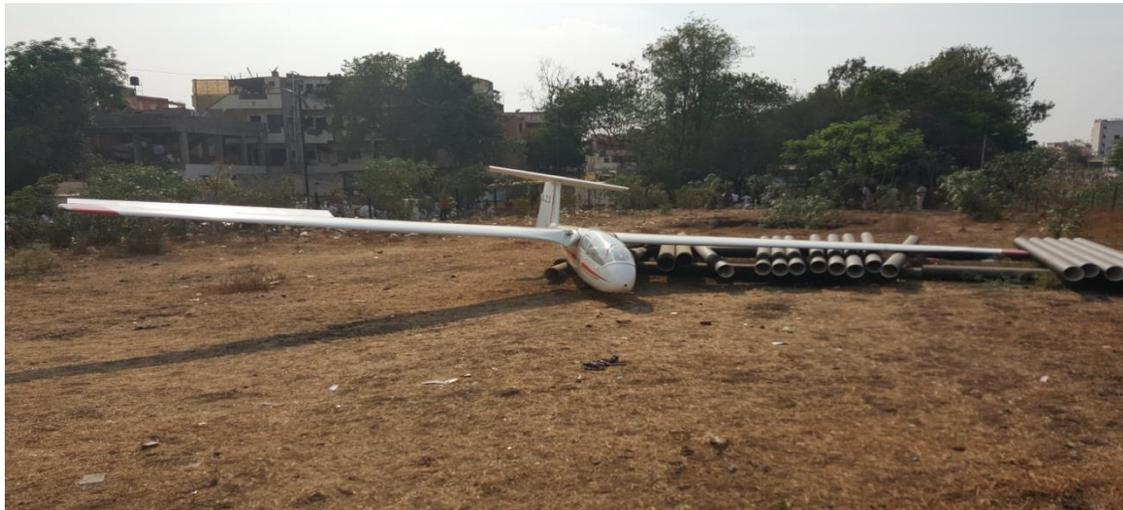
The tailwheel of the glider got entangled with overhead electrical wire which is approximately 25 feet above the ground level and this resulted into lateral spun of glider around 180 degree.

Fig: Final resting position of glider after Outfield landing

The wire got broken due to extreme tension developed and glider crash landed on the stack of pipes lying on the ground with left bank condition completely resting on the pipes and the starboard wing up. Electric wires acted as an arrestor barrier which prevented the glider to crash land in the canal as no more sufficient ground was available for landing roll.

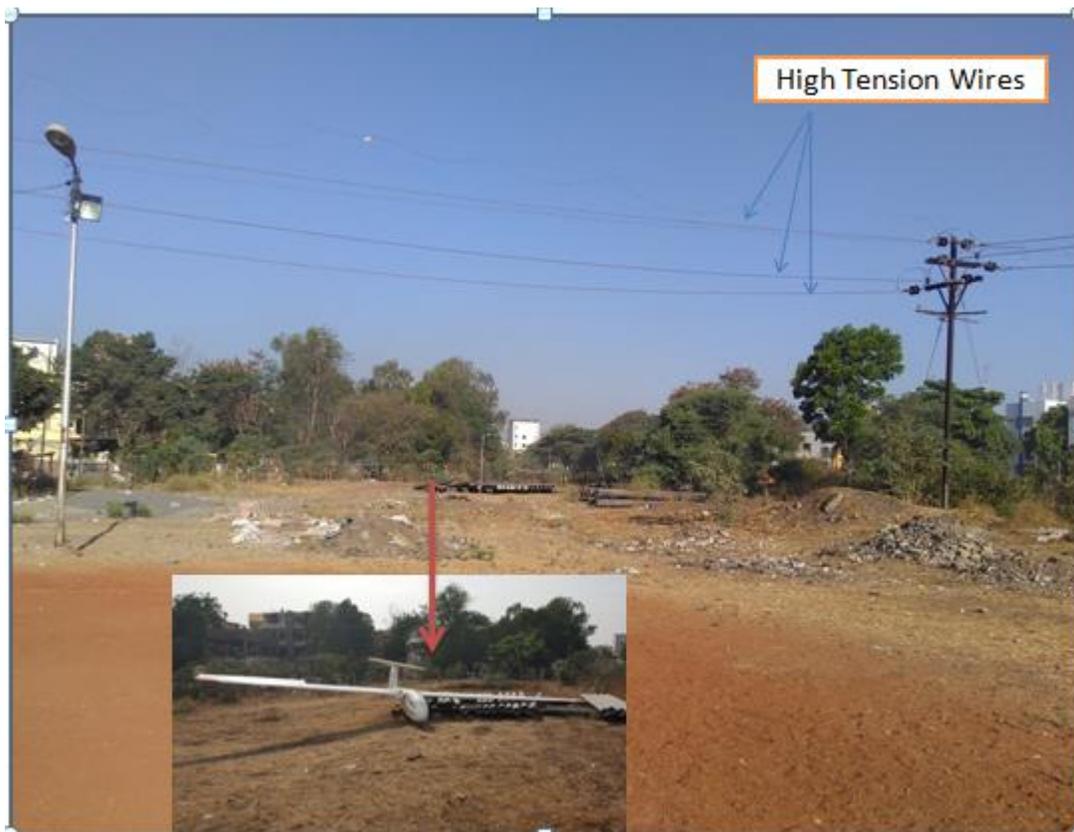
Fig: Location of Electric Wires

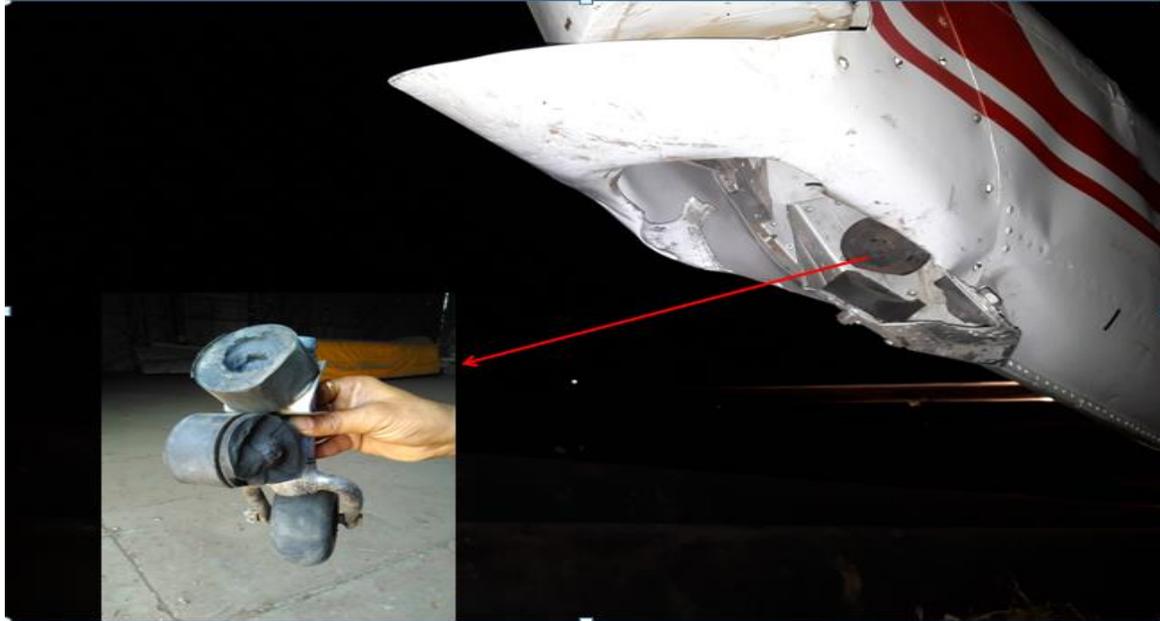
Due to single point impact on tailwheel assembly, tailwheel of the glider disintegrated and was found at a distance of 50 feet from the point of impact with over

head electric wire and subsequently the Left horizontal stabilizer also had hit the electric wire.

Fig: Disintegration of Tailwheel

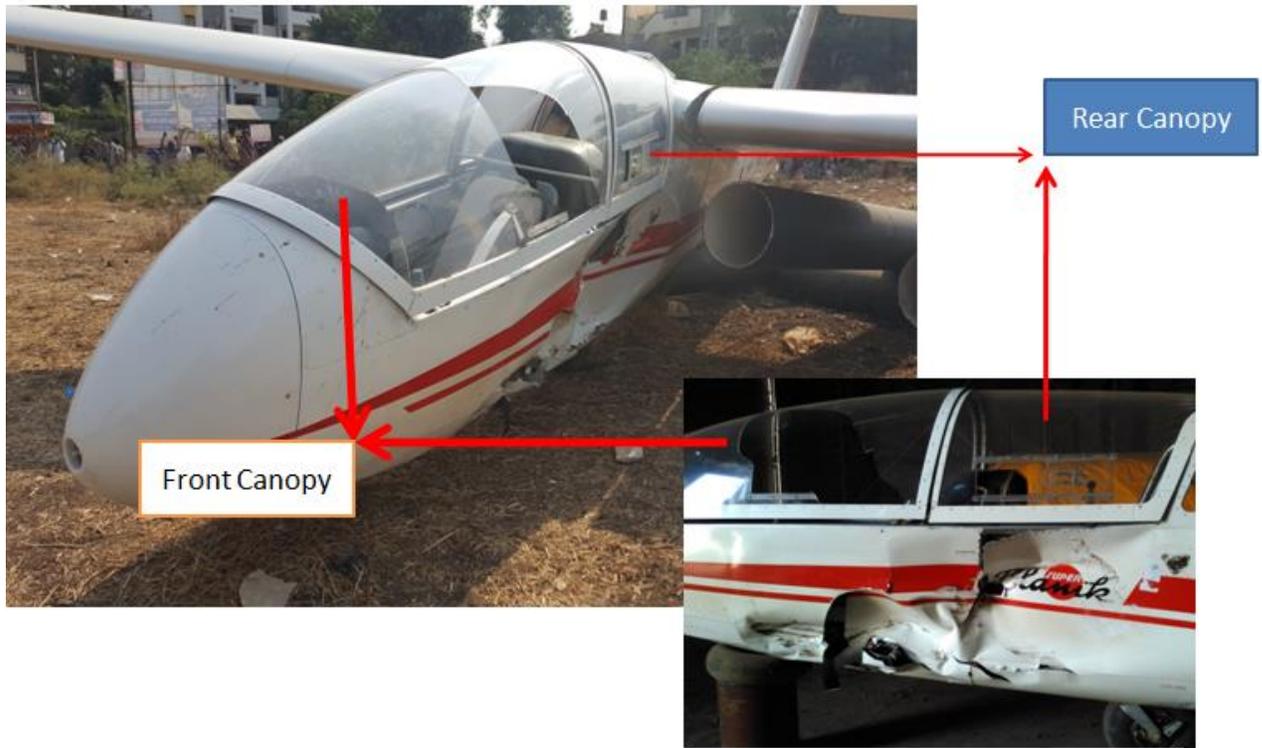
Side View of the Fuselage

Examination of the wreckage revealed that left side fuselage section 3 to 6 was completely damaged due to the heavy impact on stacked pipes. Belly portion of nose at section 2 – 3 of the fuselage got heavy dent and front canopy cover found broken but operational.

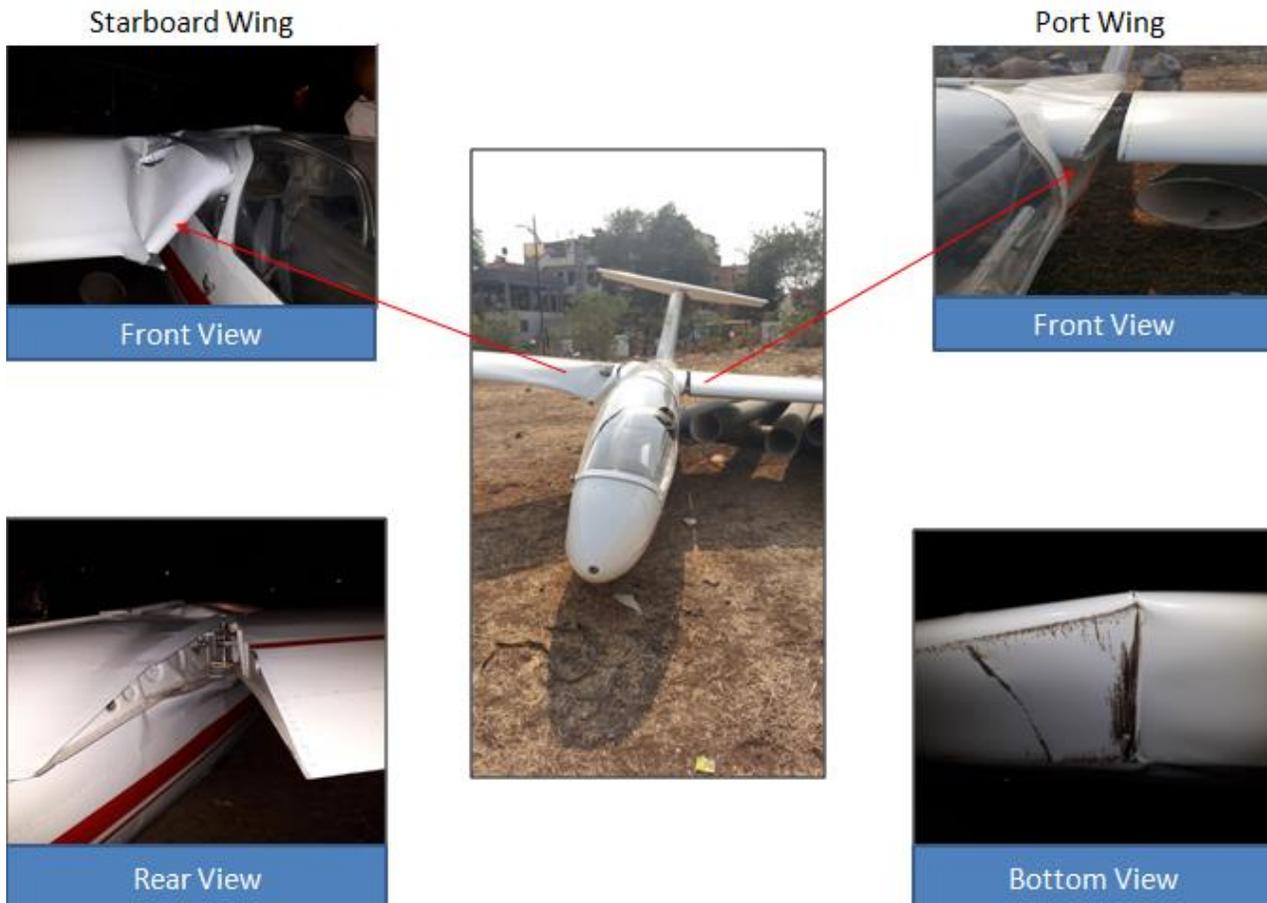
Deformation and metal sheet undulation found at the left wing root section. The left wing lower surface at section 12,13 and 14 also got damaged and the fuselage skin got deformed at section 9,10 and 11. The fuselage tail at section 13 and 14 also damaged and deformed. Due to heavy impact the right wing root got completely deformed and the wing surface got buckled. The right wing – fuselage attachment got deformed and sustained damage.

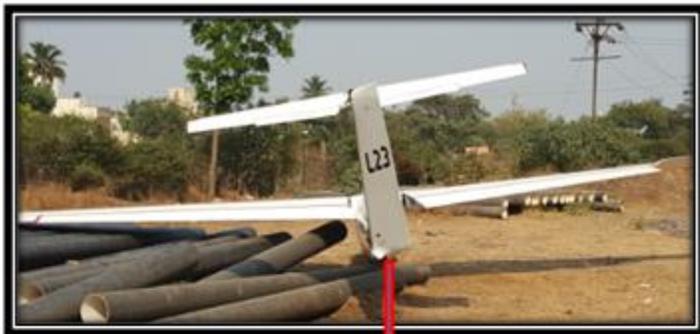
Rudder deflection

Position of damaged rudder pedal and rudder depicts that the rudder was deflected towards the right with a forceful action during the flying and which is in line to final rudder position.

It is evident that excess use of rudder resulted in side slipping and very high drag as the fuselage moved sideways through the air. This acted as an airbrake and inevitably caused a loss of airspeed with a high rate of sink even though the nose had not been raised. There is a tendency for glider to overbank at very low speeds so that a large stick deflection to hold off the bank can also be a warning of a dangerously low speed. In either case, a glider with high glide ratio would have not reached the point of intended landing.

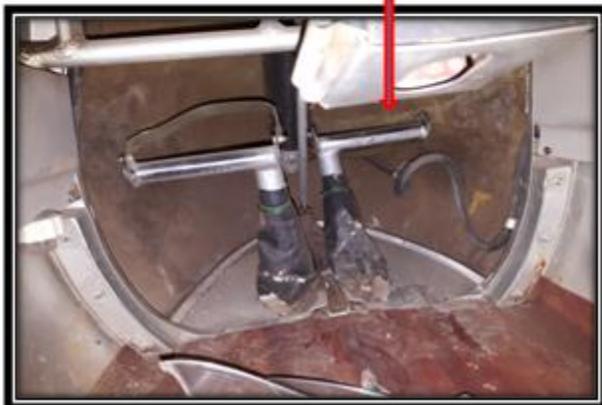
Apart from the damage to the different areas of fuselage, inside the front cockpit, RH side rudder pedal was found damaged as shown in the Fig.

Right side Rudder Pedal damaged
