**FINAL REPORT ON ACCIDENT TO M/S
RAJASTHAN AEROSPORTS CLUB PVT. LTD.,
X AIR-F MICROLIGHT AIRCRAFT VT-UAG
AT MEERUT, UTTAR PRADESH ON
12/05/2012**

GOVERNMENT OF INDIA
MINISTRY OF CIVIL AVIATION
COMMITTEE OF INQUIRY VT-UAG

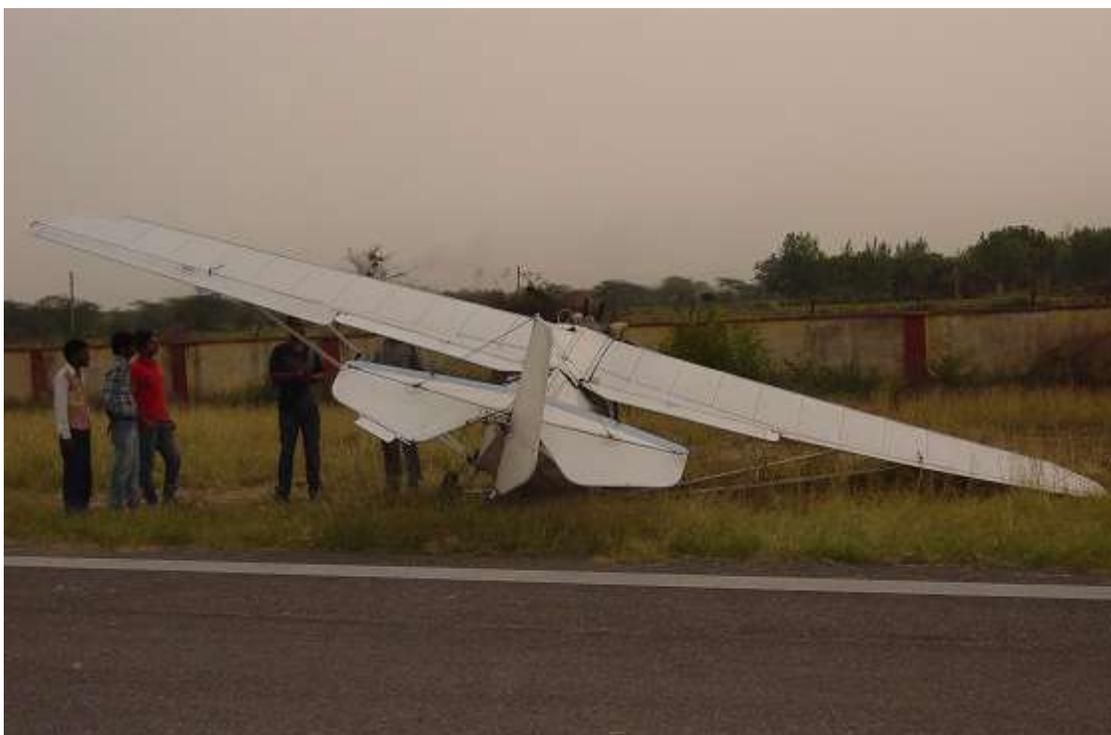
Fig showing the rear view of the aircraft with no damage to the aircraft (LH wing) and damage to right wing at the tip due scrapping & aircraft veered to the right.

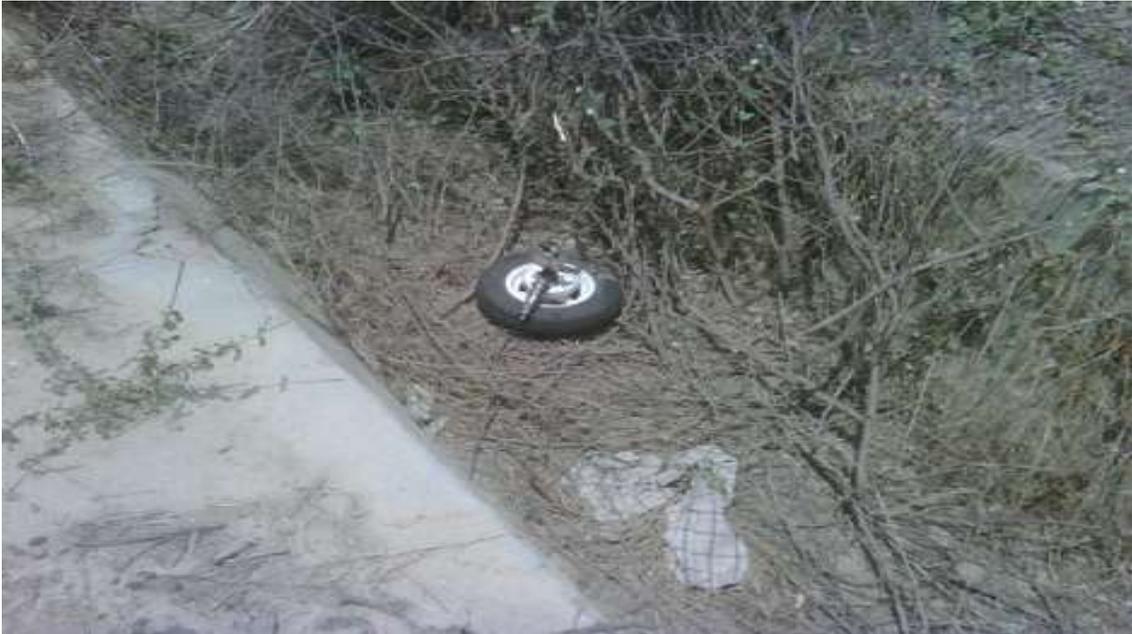
The Right landing gear was broken from its attachment point with the aircraft structure after impact with the owner on ground. Right landing gear strut also damaged. The right wing was damaged during landing due scrapping on the runway & thereafter the aircraft veered to the right.

Fig. showing Right undercarriage which got separated from the aircraft after collision with the person during low-pass exercise.

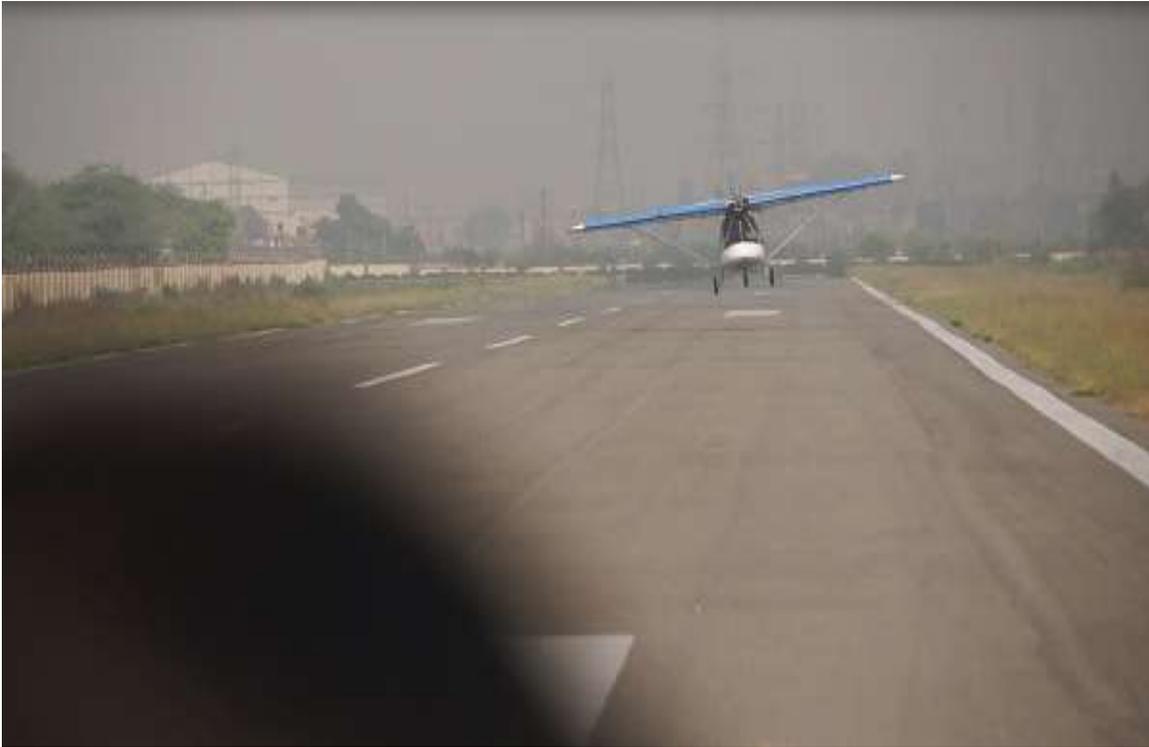
Fig. Showing the movement of the person from right to left when the aircraft is approaching runway 11

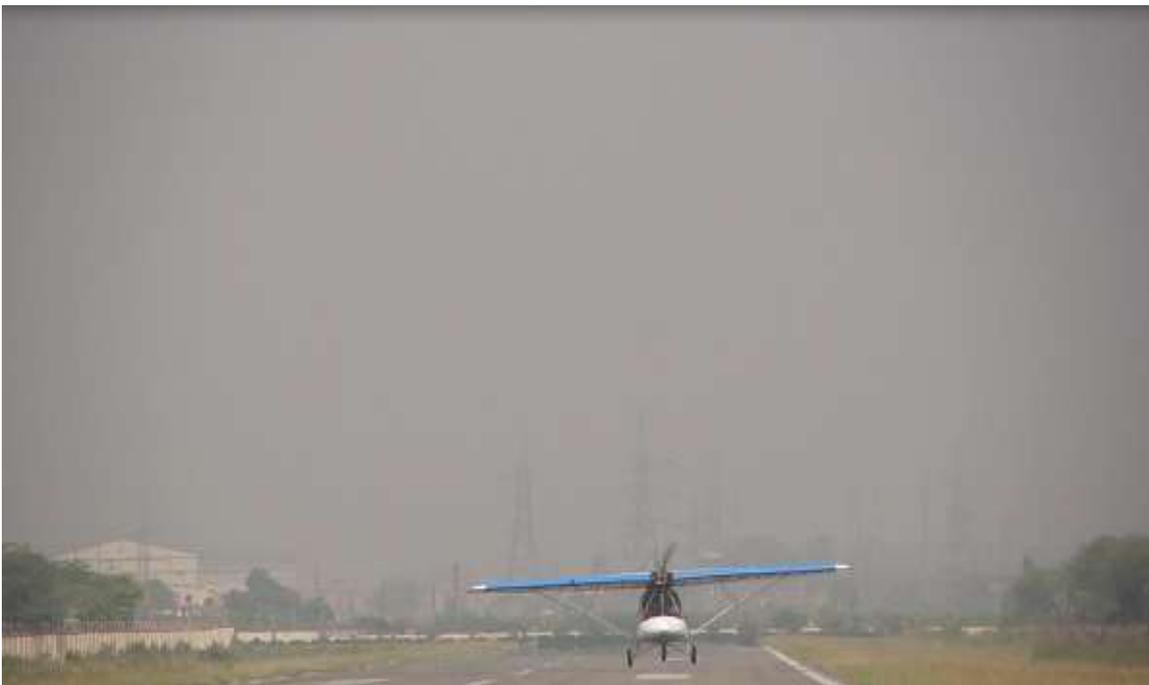
Fig. Showing aircraft is veering to the left while approaching the runway 11

11. Just before landing the examiner pilot was observed running on the centre line of runway thereby causing runway incursion.
12. The aircraft during accident sortie was observed to have veered to the left edge and at that time there was movement of persons on the runway from right to left.

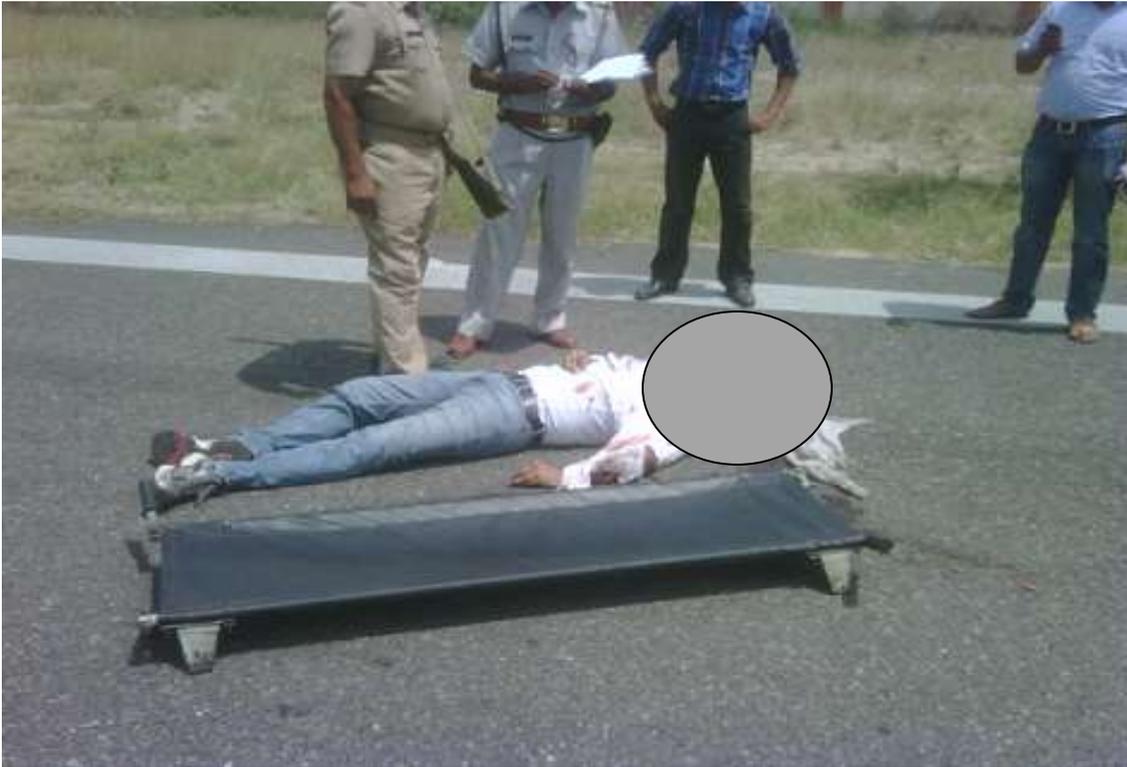
The owner of the aircraft after attaining head injuries was taken to P.L. Sharma, District Hospital, Meerut for the post mortem (PM) examination. As per the PM report the cause of the death was due to shock and haemorrhage as a result of antemortem injuries.

Fig. Showing Dead Body of Mr. Yogesh Garg lying on Runway
