**GOVERNMENT OF INDIA
MINISTRY OF CIVIL AVIATION
AIRCRAFT ACCIDENT INVESTIGATION BUREAU**

**FINAL INVESTIGATION REPORT OF
SERIOUS INCIDENT TO M/S JET AIRWAYS
LTD. ATR 72 AIRCRAFT VT-JCS
AT HYDERABAD ON 07/06/2014**

FINAL INVESTIGATION REPORT OF SERIOUS INCIDENT TO M/S JET AIRWAYS
ATR 72-212A AIRCRAFT VT-JCS AT HYDERABAD ON 07/06/2014

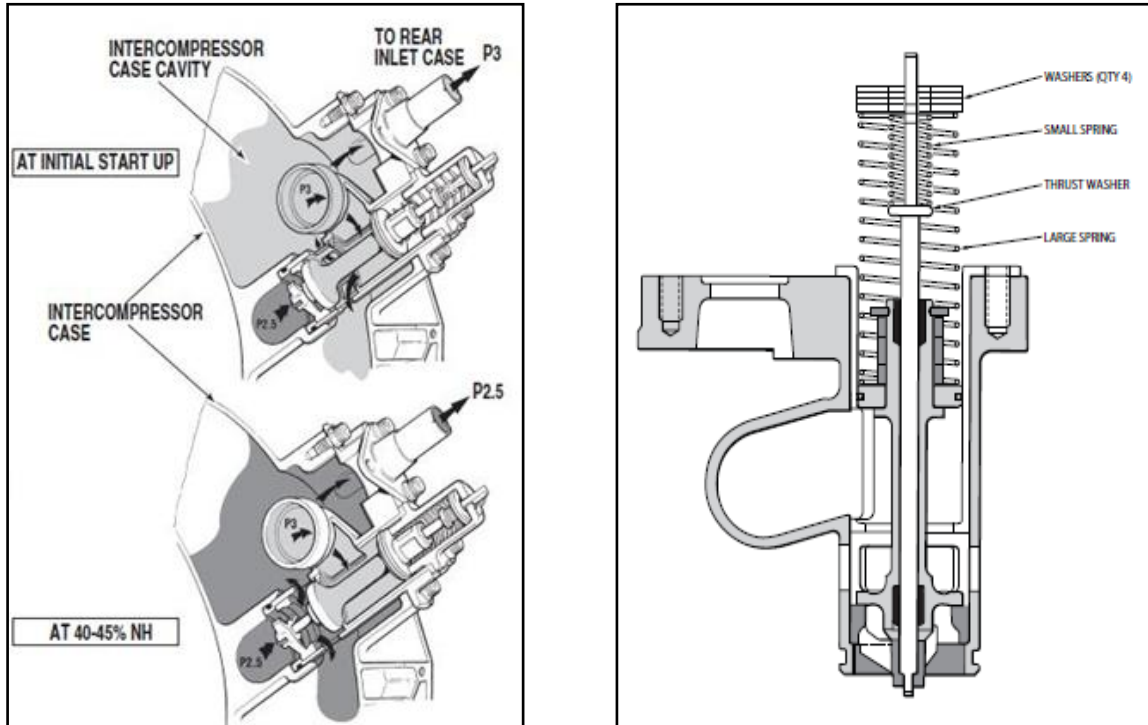
BEARING COMPARTMENT SEALING

The engine provides air bleed extraction ports from both compressors i.e. the low pressure (LP/P2.5) and the high pressure (HP/P3), as the two bleed ports are connected to the same duct. A P2.5 check valve is installed in the low pressure port to prevent back flow from the high pressure compressor (P3) to the low pressure compressor (P2.5).

The P2.5/P3 air pressure switching valve ensures an adequate air supply for bearing cavity sealing.
