**FINAL INVESTIGATION REPORT ON ACCIDENT TO  
GLIDER CENTRE PUNE L-23 SUPER BLANIK GLIDER  
VT-GLK AT GONDHALE NAGAR , PUNE ON  
09/03/2016**

On 09<sup>th</sup> March 2016, L23 Super Blanik glider, VT-GLK operated and owned by DGCA was involved in an accident during routine glider flying at Gondhale Nagar near Glider Center Pune, Hadapsar around 0900UTC.

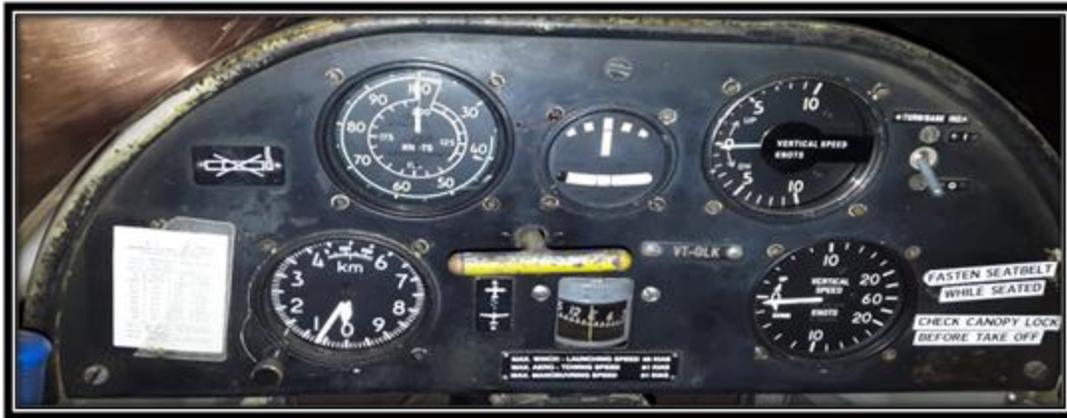
Front Cockpit-Instrument Panel

The instrument panel and instruments of both front and rear cockpit were found attached in place without any damage. The safety harness was intact and the main undercarriage was also intact and no damage was observed. All the attachment pins locks and all the control surfaces (Ailerons, Elevators, Rudder, trim tabs and Airbrake) were in place and found intact. However, Starboard side rudder pedal was found damaged. The rear canopy cover found satisfactory and there was no disintegration of any part in air. Altimeter of the rear cockpit was found stuck at max due to the tailwheel impact with the overhead electric wire and other than this all the instruments showing actual reading positions.
