**FINAL REPORT ON SERIOUS INCIDENT OF
PILOT INCAPACITATION TO M/s SPICEJET
LTD. BOEING 737-800 AIRCRAFT VT-SZD AT
HYDERABAD ON 08/01/2014**

FINAL REPORT ON SERIOUS INCIDENT TO M/s SPICE JET BOEING 737-800 AIRCRAFT VT-SZD AT HYDERABAD ON 08/01/2014

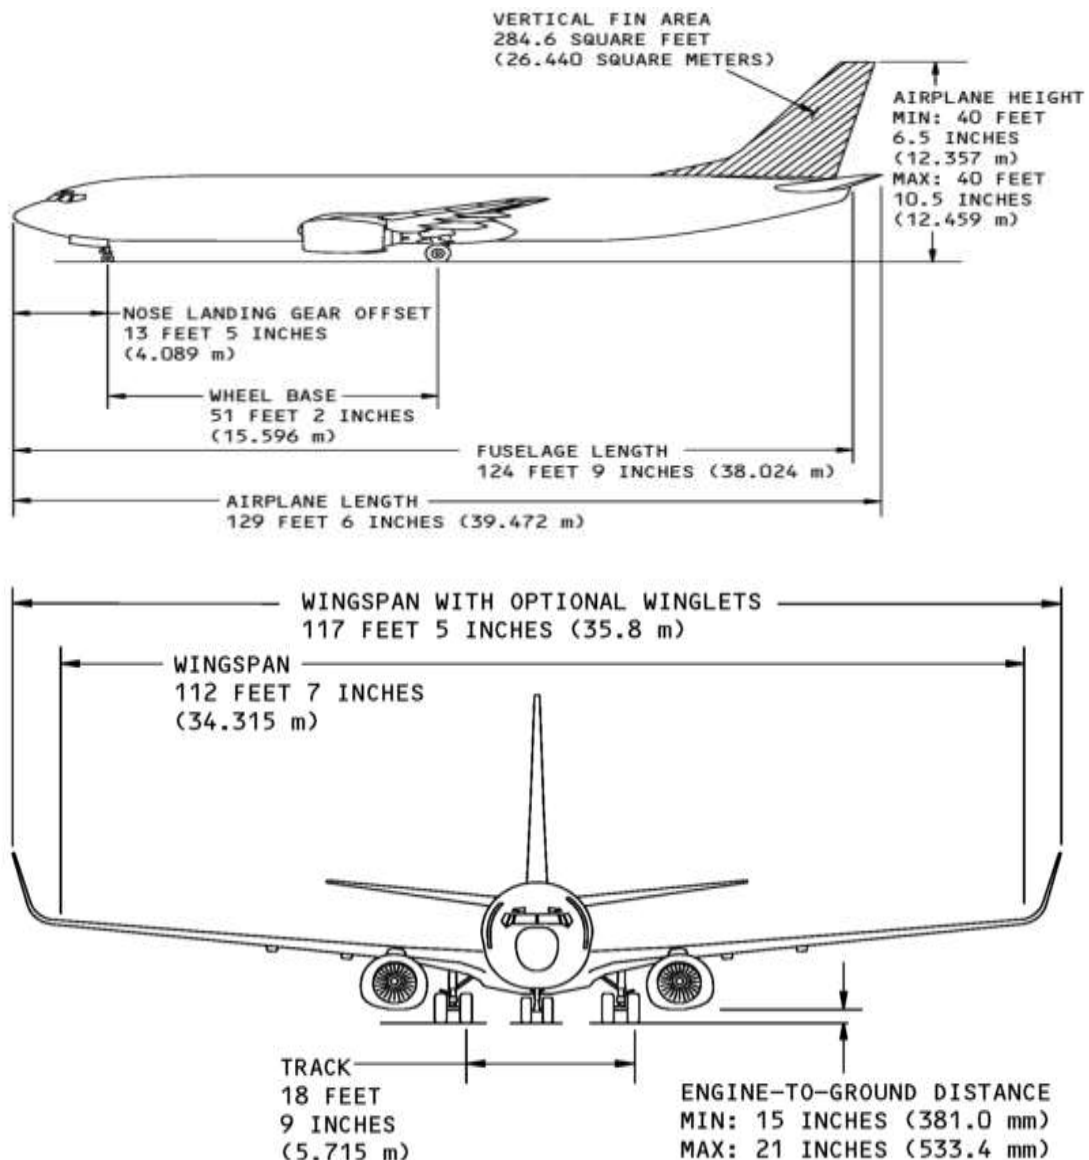
Boeing 737-800 is a Twin engine aircraft fitted with CFM 56-7B Engine and is manufactured by CFM. This aircraft is certified in Normal category, for day and night operation under VFR & IFR. The maximum operating altitude is 41000 feet and maximum takeoff weight is 70,987 Kgs. Aircraft length is 39.472meters, wingspan is 35.8 meters and height of this aircraft is 12.459meters. This airplane is certified in the Transport Category, FAR Part 25 and Part 36.

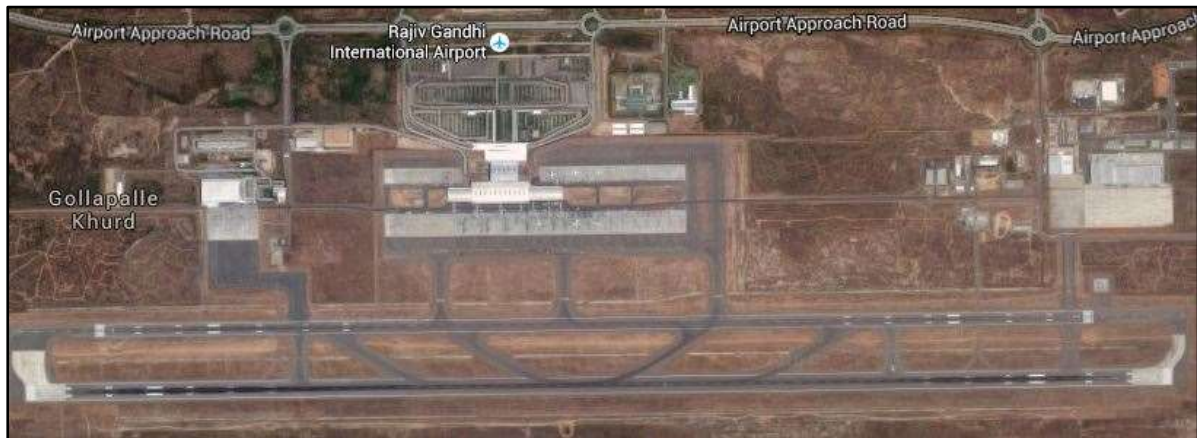
Parallel runway 09R & 09L at Shamshabad International Airport, Hyderabad
